# Addendum to Upper Clark Fork River Tributaries Sediment, Metals, and Temperature TMDLs and Framework for Water Quality Restoration

**April 2014**

Water Quality Planning Bureau  
Watershed Management Section

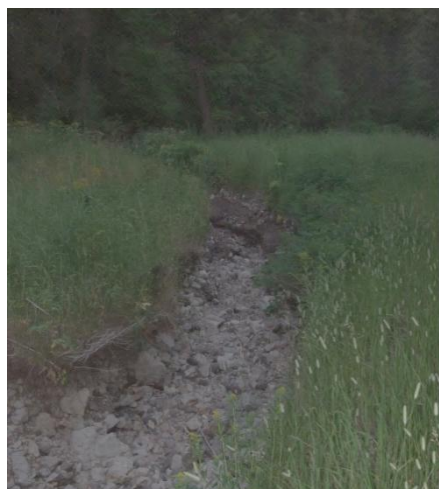
**Figure 5-1. Dry Section of Warm Springs Creek in Canyon Upstream of the Anderson Mine Facility**

reach, the riparian area included only sparse woody shrubs and trees with little overhead cover and shade. Additionally, there was a lack of woody debris in the channel in the survey reach. Extensive past timber harvest activities was noted upstream of RM 11.5 in the upper portions of the watershed. The stream goes dry during summer at approximately RM 6.1. The extent of this condition was not determined by FWP (Liermann et al., 2009), although the channel remains dry upstream of RM 6.1 for over a mile (**Figure 5-1**).
